Detex Exit Device

TROUBLESHOOTING

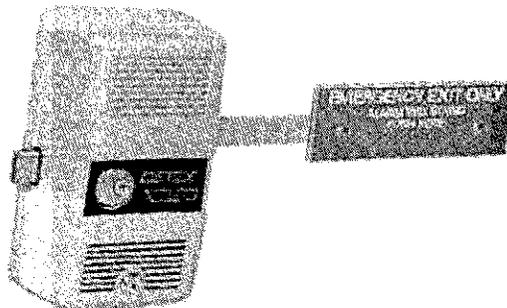
- F) Remove the *cylinder housing (Cam bridge Assembly)*. With the key removed, confirm the timing markings (Fig. 1).
- G) If the timing marks do not line up then reinstall the cylinder (per instructions).

- H) If the cylinder turns hard, the tail piece is too long and needs to be cut as Fig. 2.
Fig. 2 denotes Detex cylinder ECL-445, 5 pin. For 6-7 pin rim cylinder use ECL-1595 escutcheon and cut tailpiece accordingly.

- I) Insert the key in the cylinder and turn it clockwise/counter-clockwise. The cam and the key should turn freely. If the key turns, but not the cam, the *cylinder tail piece* was cut too short and has slipped out of the cam. Replace the tailpiece or the cylinder (Fig. 2).

- A) Remove the unit from the door.
- B) From the rear side of the casting, confirm the retaining spring was removed (Fig. 3).
- C) Confirm the OKC shaft/cam is not broken and the push nut is in place.
- D) Confirm the tailpiece length is 5/8" beyond the door or beyond the reinforcing plate (Fig. 3).
- E) Confirm the index mark alignment (Fig 3).
- F) While the unit is off the door, check the OKC operations. Using a screw driver, turn the cam clockwise/counter-clockwise.
- G) Retract the bolt, align the index marks, remove key, re-install the lock body (make sure the alignment mark does not move when reinstalling the lock body). Be sure the cylinder tailpiece is engaging the cross slot on the cam (Fig. 3).
